Manhole Inspection Summary

Manhole # S17M__029MH

Insp Date: **4/11/08 2:20 PM**

Location Address: **2624 lehman st**

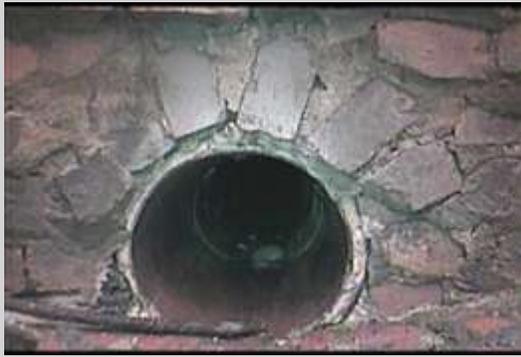
12 O'Clock Outflow

8 in. Circular Gravity Sewer
Pipe Out @ 12 O'Clock

Pipe Height: **8.4** (in.) Rod and Bar (Angled)
Pipe Material: **Clay** Pipe Lined
Invert Depth: **5.62** (ft.) Flow Characteristics:
Deposits: None Mud Sludge Debris Grease
Silt Depth: **0** (in.) Deposits Extent:
Infiltration: Pipe Seal Cond:
